# NAVAL POSTGRADUATE SCHOOL

# **THESIS**

# EFFECTS OF CARBON NANOMATERIAL REINFORCEMENT ON COMPOSITE JOINTS UNDER CYCLIC AND IMPACT LOADING

March 2012

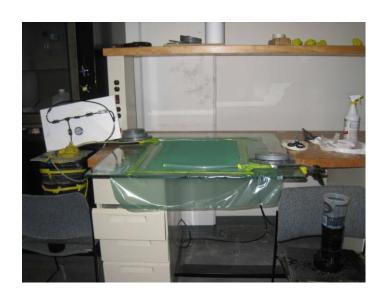
Figure 6. VARTM setup in the laboratory

Figure 6 showed the setup of VARTM in the laboratory. The vacuum created via the vacuum pump would draw the liquid resin, from the reservoir, through the layers of carbon fabrics. The excess resin was drained into the resin trap. The composite laminate was left to cure and harden for 20 hours prior to removal.

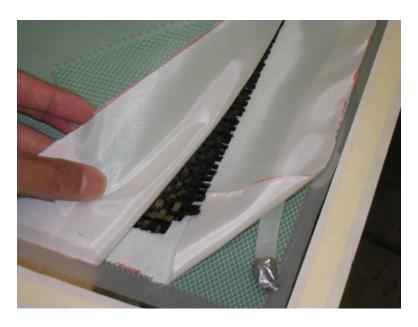
Figure 7. Arrangement of the various layers

Teflon® film was first laid out on the glass surface to facilitate the removal of laminate after curing and to prevent hardening of excess resin on the surface. A layer of distribution media followed by a layer of peel ply was laid out before placing the layers of carbon fiber fabrics on top of the peel ply. The peel ply and distribution media should be about 100mm longer and 40mm wider than the size of the fabrics. Next, another layer of peel ply followed by a layer of distribution media was placed on top of the fabrics. The peel ply prevented the distribution media from adhering to the laminate during curing and yet allowed the smooth flow of the resin through the fabrics. The setup of the various layers was shown in Figure 7.

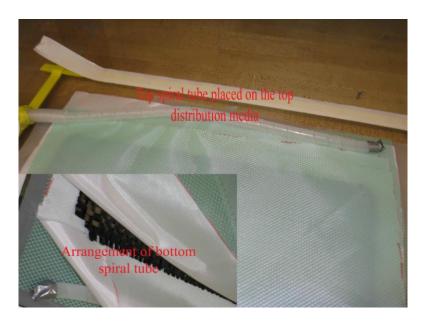
Figure 8. Arrangement of spiral tubes

Spiral tubing was placed at the top and bottom edge of the laminate setup to facilitate the flow of the resin. The top spiral tubing was placed on top of the top distribution media layer while the bottom tubing was placed in between the bottom distribution media and peel ply. This setup, shown in Figure 8, allowed the resin to be drawn from the bottom, through the carbon fiber layers and out through the top tube to ensure more thorough distribution. The top and bottom spiral tubing were connected to the 0.5" solid walled polyethylene outlet (resin trap) and inlet (resin reservoir) tubing, respectively.

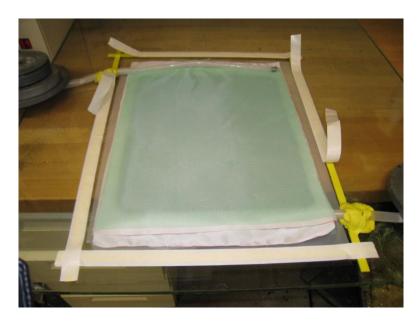
Figure 9. Sealing tape around the sample

The vacuum sealing around the sample was achieved using sealing tape and a vacuum bag (refer to Figure 9 and 10). A lump of sealing tape was used as a stopper to block the opening end of the inlet tube to build up the vacuum. The vacuum status was checked using the vacuum gauge connected in the setup.

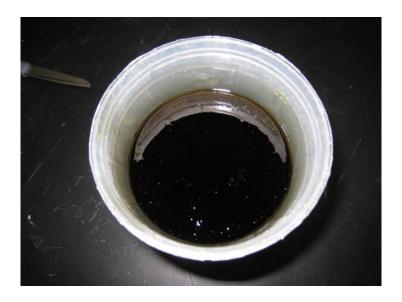
Figure 11. Resin mixture with most air bubbles dissipated

The ambient temperature was noted and the appropriate chemical concentrations, according to Table 1, were mixed with the resin in a bucket. Each chemical should be thoroughly mixed with the resin before adding the other chemical, to prevent a direct reaction between the hardening chemicals. The mixture was left to rest for about 15–20 minutes, allowing most of the air bubbles to escape as shown in Figure 11. These air bubbles, if allowed to draw through, would trap within the matrix of the sample and weakened the final product. However, the mixture should not be left to rest for too long as it might start curing. It was advised to mix in the DMA, if required, prior to drawing the resin through the fabrics.

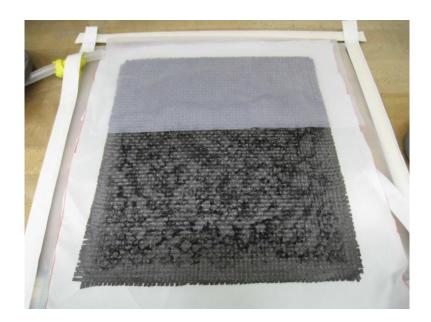
Figure 13. Dispersion of CNTs/CNFs and laying of Teflon film

The bottom layer of the test coupon was completed. The next step was to fabricate the complete test sample with the appropriate pre-cracked length. The surface of the bottom layer was smoothened using a 100-grit sand paper. The sanded surface was washed down with acetone to remove any loose particles. For the reinforced samples, 7.5g/m² CNTs or CNFs were mixed with acetone and dispersed on the cleaned surface. The acetone was allowed to dry prior to the next step. A Teflon® film, shown in Figure 13, was placed on the bottom layer to create the pre-crack. Next, another five layers of carbon fiber plain weave fabrics were laid on top and a repeat of the VARTM process produced the final sample. The samples were then cut into the required testing dimensions using a water-jet cutting machine.

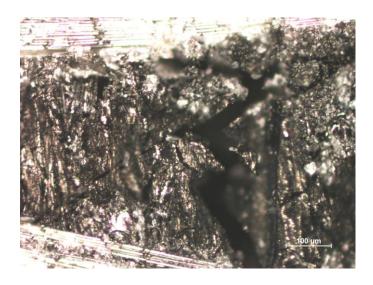
Figure 24. Perpendicular crack blocking crack propagation

Very different crack propagation paths were observed in both the CNTs-reinforced and CNFs-reinforced samples. Perpendicular and 45° crack propagations were widely observed in those samples (refer to Figure 24 and 25). The CNTs and CNFs reinforcement provided strong resistance to the crack propagation, making it more difficult for crack growth. This resulted in the crack propagation seeking alternative path with lower resistance, which were regions with lower or little concentration of reinforcement due to uneven dispersion of CNTs/CNFs. The stronger CNTs and CNFs bonded with the resin matrix increased the facture toughness of the joint interface. There were also evidences of crack nucleation away from the plane/path of the crack propagation but still along the joint interface. These were shown in Figure 25 and 26.

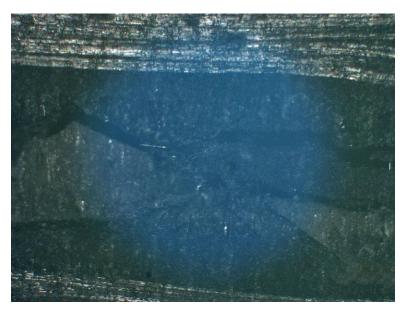
Figure 33. 'Shattered' crack pattern on CNTs-reinforced sample after impact test

The samples were viewed under microscope with 2.5x magnification. The crack patterns for the non-reinforced samples were observed to be straight-through. On the CNTs-reinforced samples, multiple cracks or 'shattered' patterns were widely observed (refer to Figure 33). This showed that the strong CNTs bonded in the resin provided resistance to crack propagation. Higher impact force was thus required for the crack to propagate through. The crack patterns on the CNFs-reinforced samples did not differ much from that of non-reinforced samples (refer to Figure 34 and 35). The observations matched the previous discussion on the failure drop height experienced by the respective samples.

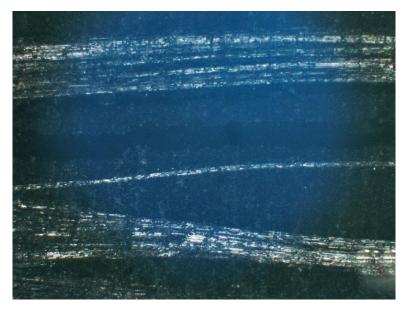
Figure 35. Crack pattern on CNFs-reinforced sample after impact test
